Engineering Geomorphological Assessment and Slope Hazard Identification of the Haast Pass Highway Corridor

State Highway Six, Haast Pass, New Zealand

Master of Science in Engineering Geology

by
Andrew Timothy Walsh
2015

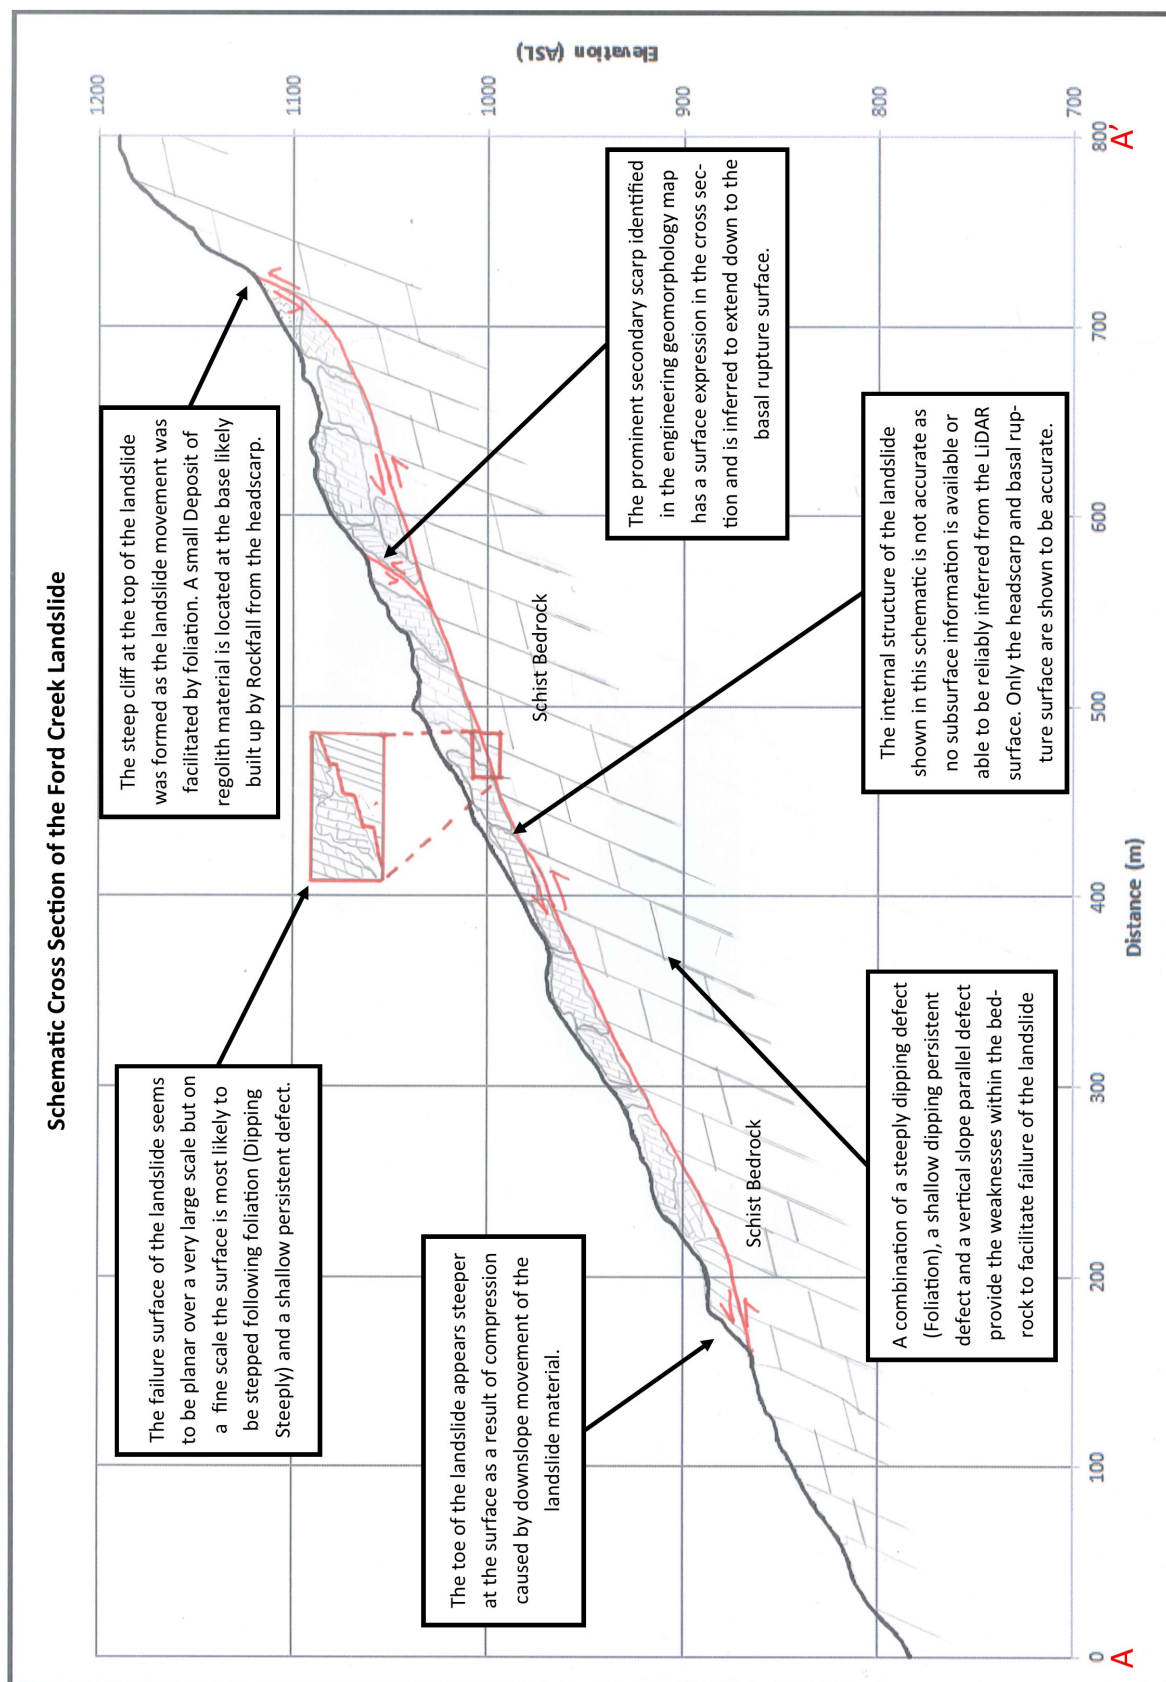
Figure 5.8: Schematic cross section through the Ford Creek landslide inferred from the LiDAR surface expression.

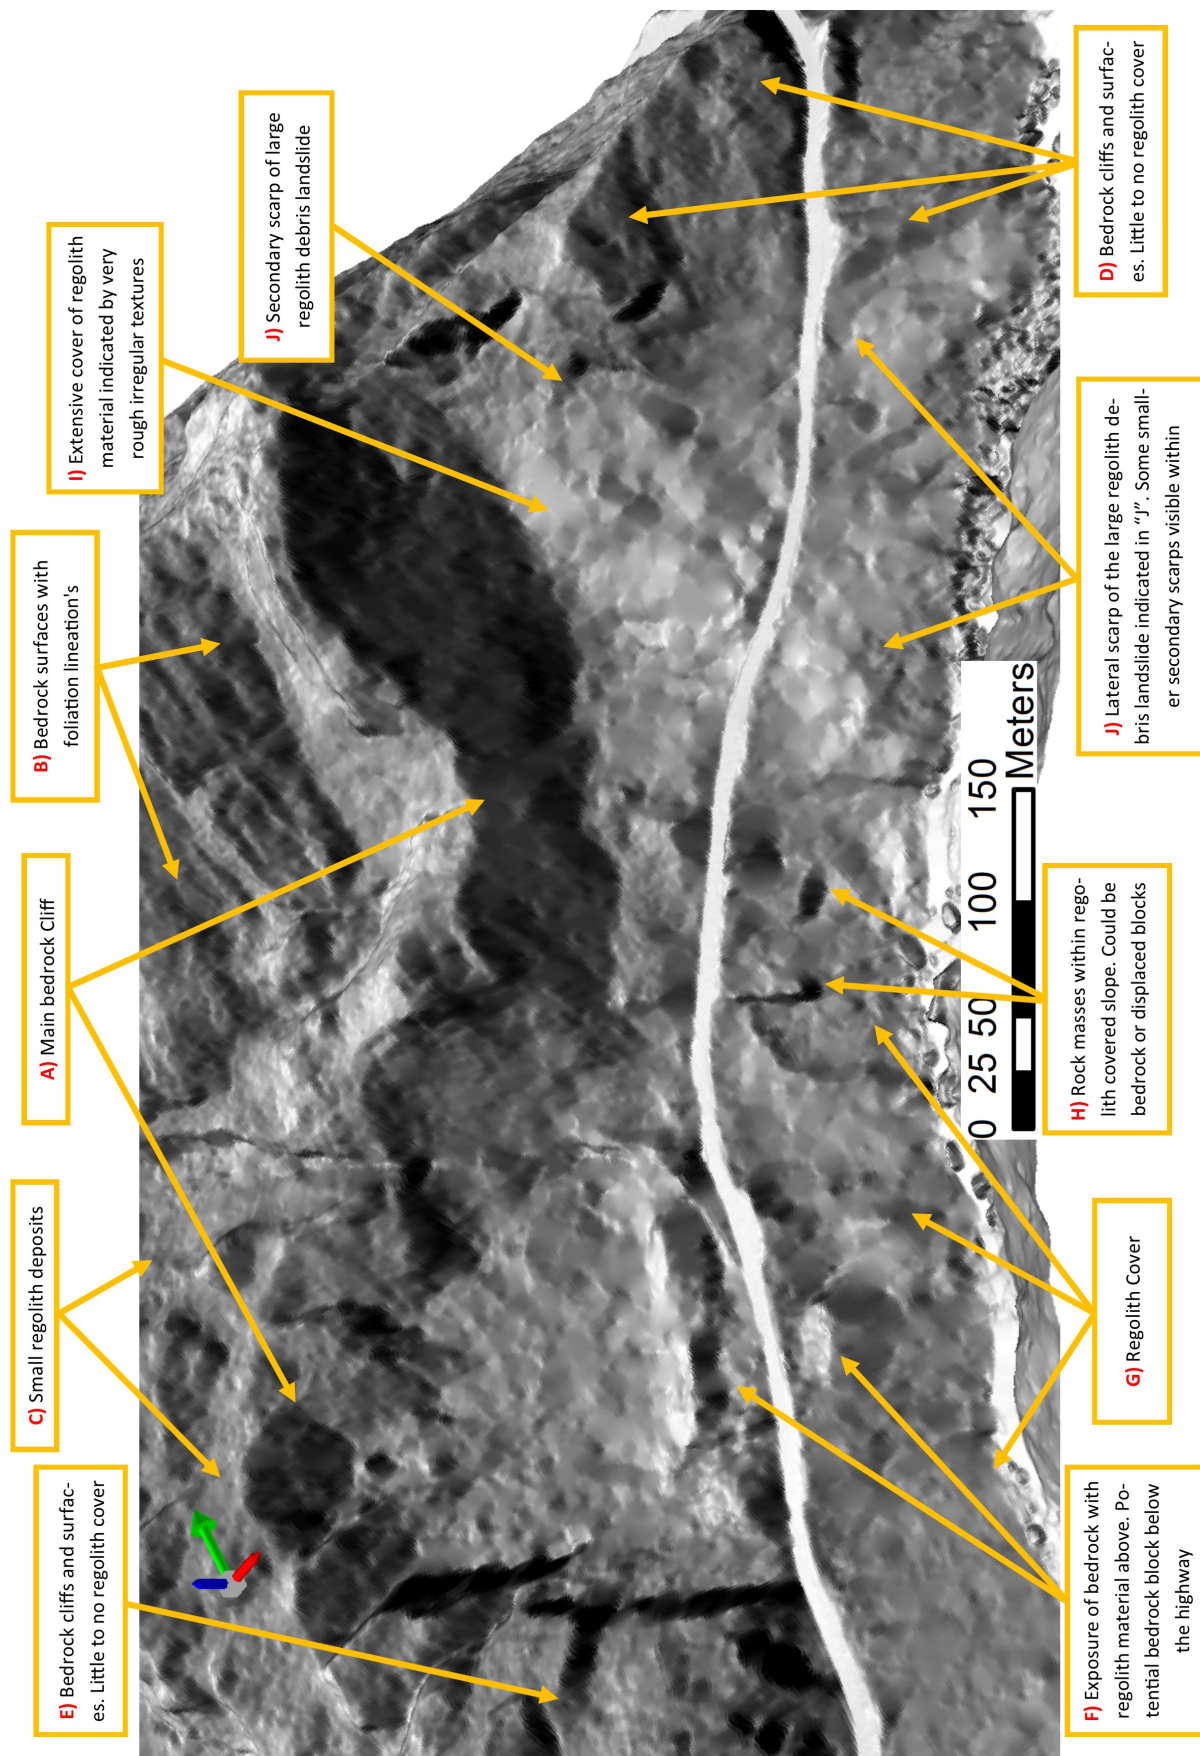
Figure 5.10: LiDAR slopeshade image of The Hinge investigation area.

There is evidence in the LiDAR surface that indicate bedrock and regolith within The Hinge investigation area have been subjected to mass movement activity. Within the investigation area many of the bedrock areas consist of steep cliffs visible in the LiDAR image in Figure 5.10 as the very dark areas of the slopeshade image. These cliffs are formed by rockfall and rock sliding of schist rock as it fails along rockmass defects, most notably schist foliation and one more persistent rockmass joint. Evidence of failure along rockmass defects is indicated by the preferential orientation of most of the cliffs in the investigation area with most cliff faces aligned along foliation, striking 020 and dipping at around 70, and another persistent defect within the rockmass, striking approximately 110 and dipping steeply. It is failure of bedrock from the areas surrounding the regolith deposit, most likely through rockfall and rock sliding, that has resulted in the formation of the regolith deposit currently located below the cliff.

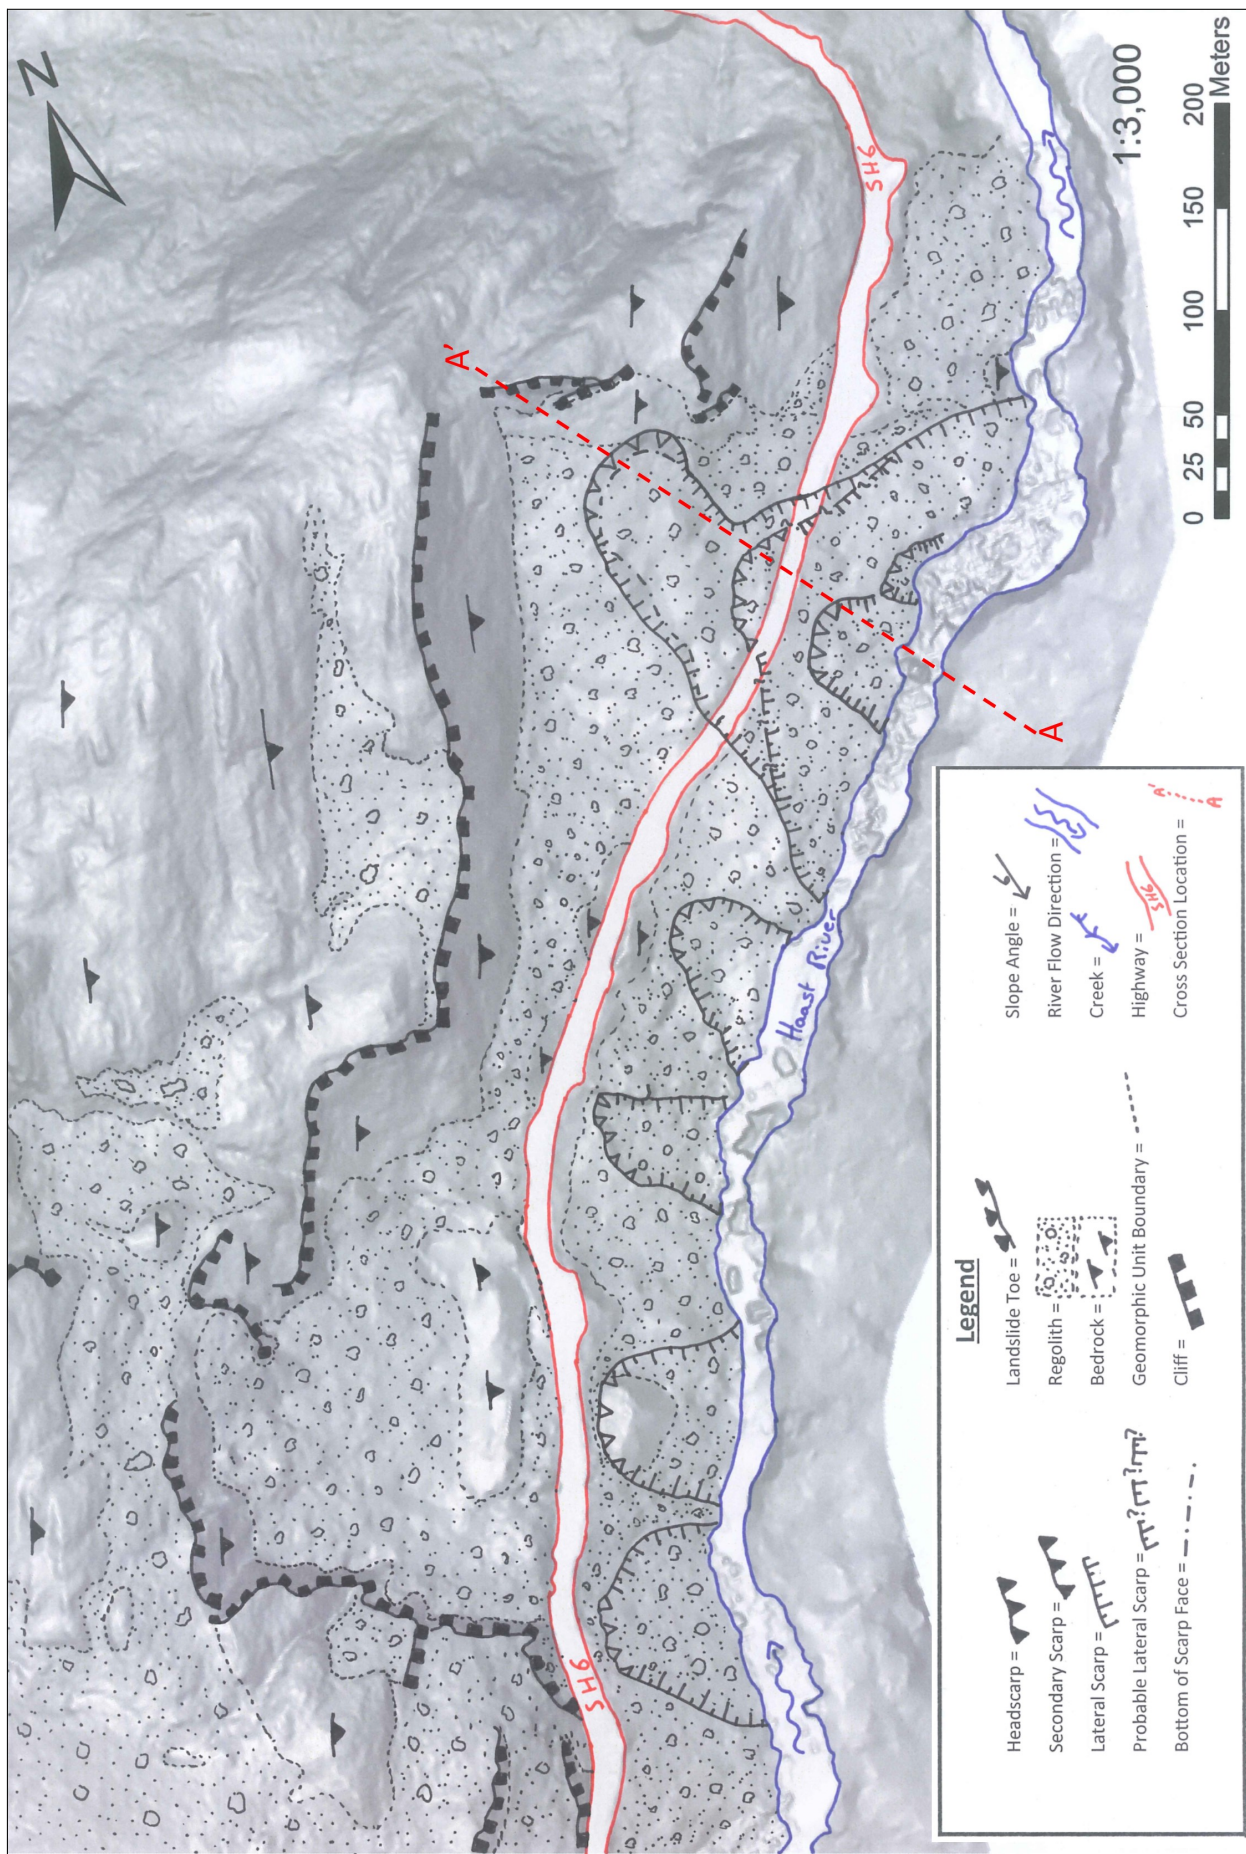
Figure 5.11: Engineering geomorphology map of The Hinge investigation area showing the distribution of bedrock, regolith materials and landslide features.

- The bedrock areas surrounding the regolith deposits and mapped in Figure 5.11 have been subjected to rockfall events in the past. The regolith material mapped covering

most of the mapping area below the steep bedrock cliff originates from the cliff above and has probably been built up by successive rockfall events. Removal of regolith material will contribute to the destabilisation of the large bedrock cliff and increases the probability of failure. The trigger is unknown at this time as is the overall condition of the rockmass but if the rockmass is sufficiently jointed it is possible the heavy rainfall, loss of support from regolith material or/and earthquake shaking could result in a rockfall event.

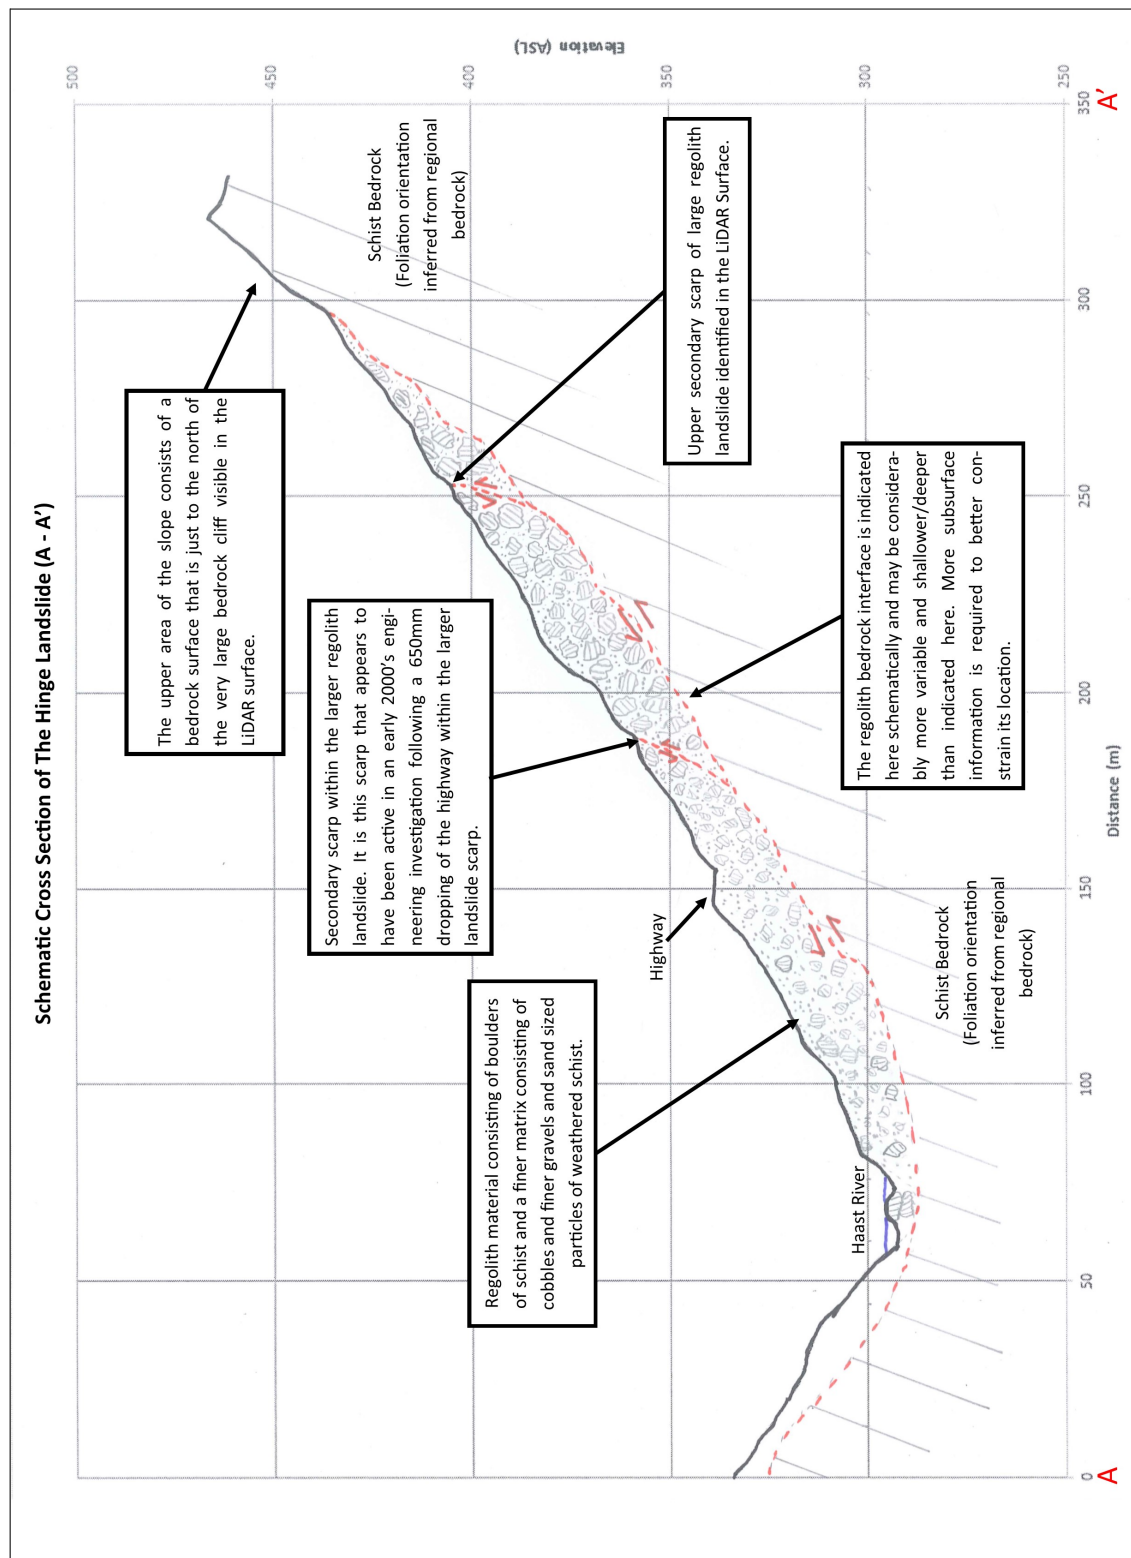
A cross section through the regolith material in the northern part of the investigation area is shown in Figure 5.12 providing an interpretation of the subsurface profile based on the overall slope morphology. This section of the slope was selected as the site for the cross section as it had clear signs of remobilisation of regolith materials in the LiDAR surface and was subjected to mass movements in the early 2000's (Opus 2001). The bedrock-regolith interface is indicated on the cross section and is only speculation as to the depth of the surface based on the surround bedrock morphology. The uppermost scarp in the regolith deposit visible in the LiDAR surface is indicative of large scale mass movement and given the size and persistence of the lateral scarps, is likely to extend deep into the regolith deposit. A smaller secondary scarp was identified within the larger landslide scarp in the LiDAR surface and corresponds with a step in the slope surface. This feature was identified in an engineering investigation following subsidence of the highway and was found to show signs of recent movement (Opus 2001); It represents a secondary landslide within the main landslide body that is likely failing along the bedrock regolith interface or a shear surface within the regolith materials. Movements of this material is likely to be strongly influence by removal of the material at the toe of the slope by the river and by heavy rainfall, as was experienced before the landslide movements in the early 2000's (Opus 2001).

Figure 5.12: Schematic cross section through The Hinge inferred from the LiDAR surface expression. The location of this cross section is indicated by the A - A' line in Figure 5.11

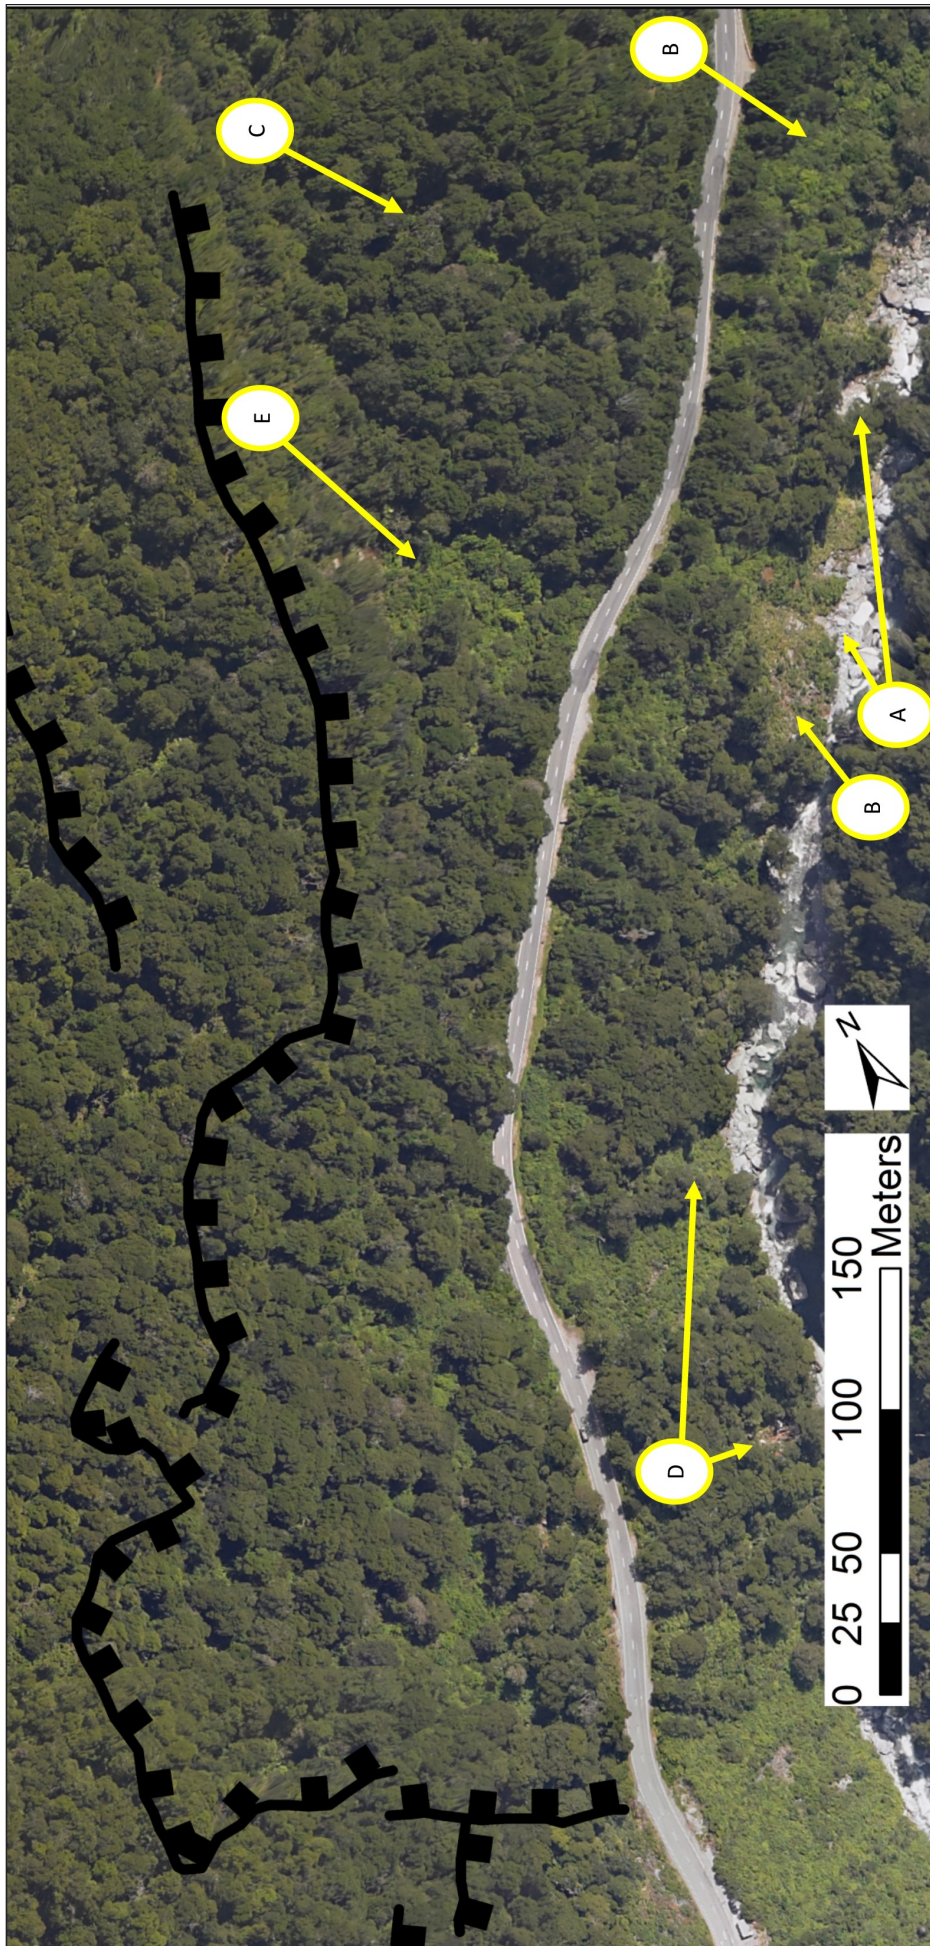
Evidence from both engineering reports (Opus 2001) and aerial photography indicate that several areas of The Hinge investigation area are subjected to ongoing mass movement activity. Fresh exposures of regolith material are visible at the base of some slopes below the highway where it appears a combination of river scour and landsliding has removed vegetation cover (Figure 5.13 A). Outside of the areas showing very recent mass movement activity there are variations in vegetation age across the rest of the slopes below the highway. These variations are likely a result of vegetation regrowth after debris slides with the areas of very young vegetation that appear as the brighter green areas in Figure 5.13 having been subjected to debris sliding more recently. The only area that appears to be active above the highway is the debris slide in the northern end of the regolith deposit within the large landslide scarps. The highway at this location was subjected to 650mm of vertical displacement in December 2000 and has been subjected to continued but lower magnitude deformations in the years since (E. Stevens, personal communication, April 21, 2014). Unfortunately, it was not possible to identify any recent landslide movement features from the aerial photo due to the very dense vegetation above the highway, however, the extent of the slumping of the highway is located within the confines of the larger regolith landslide identified in the LiDAR surface. The areas that are currently showing signs instability and mass movement appear to be confined to the slopes below the highway as well as the landslide in the northern end

Figure 5.13: Aerial photo of The Hinge. A) Exposure of regolith materials as a result of slope failures caused by river erosion. B) Location of the lateral scarps identified in the LiDAR surface with corresponding breaks in the vegetation likely caused by loss of vegetation due to landsliding. C) Location of the headscarp of the large regolith debris slide identified in the LiDAR surface. D) Small failures of regolith material below the highway indicated the an area of young vegetation and a visible landslide with regolith material exposed. E) Young vegetation likely indicating past landslide activity at this location.

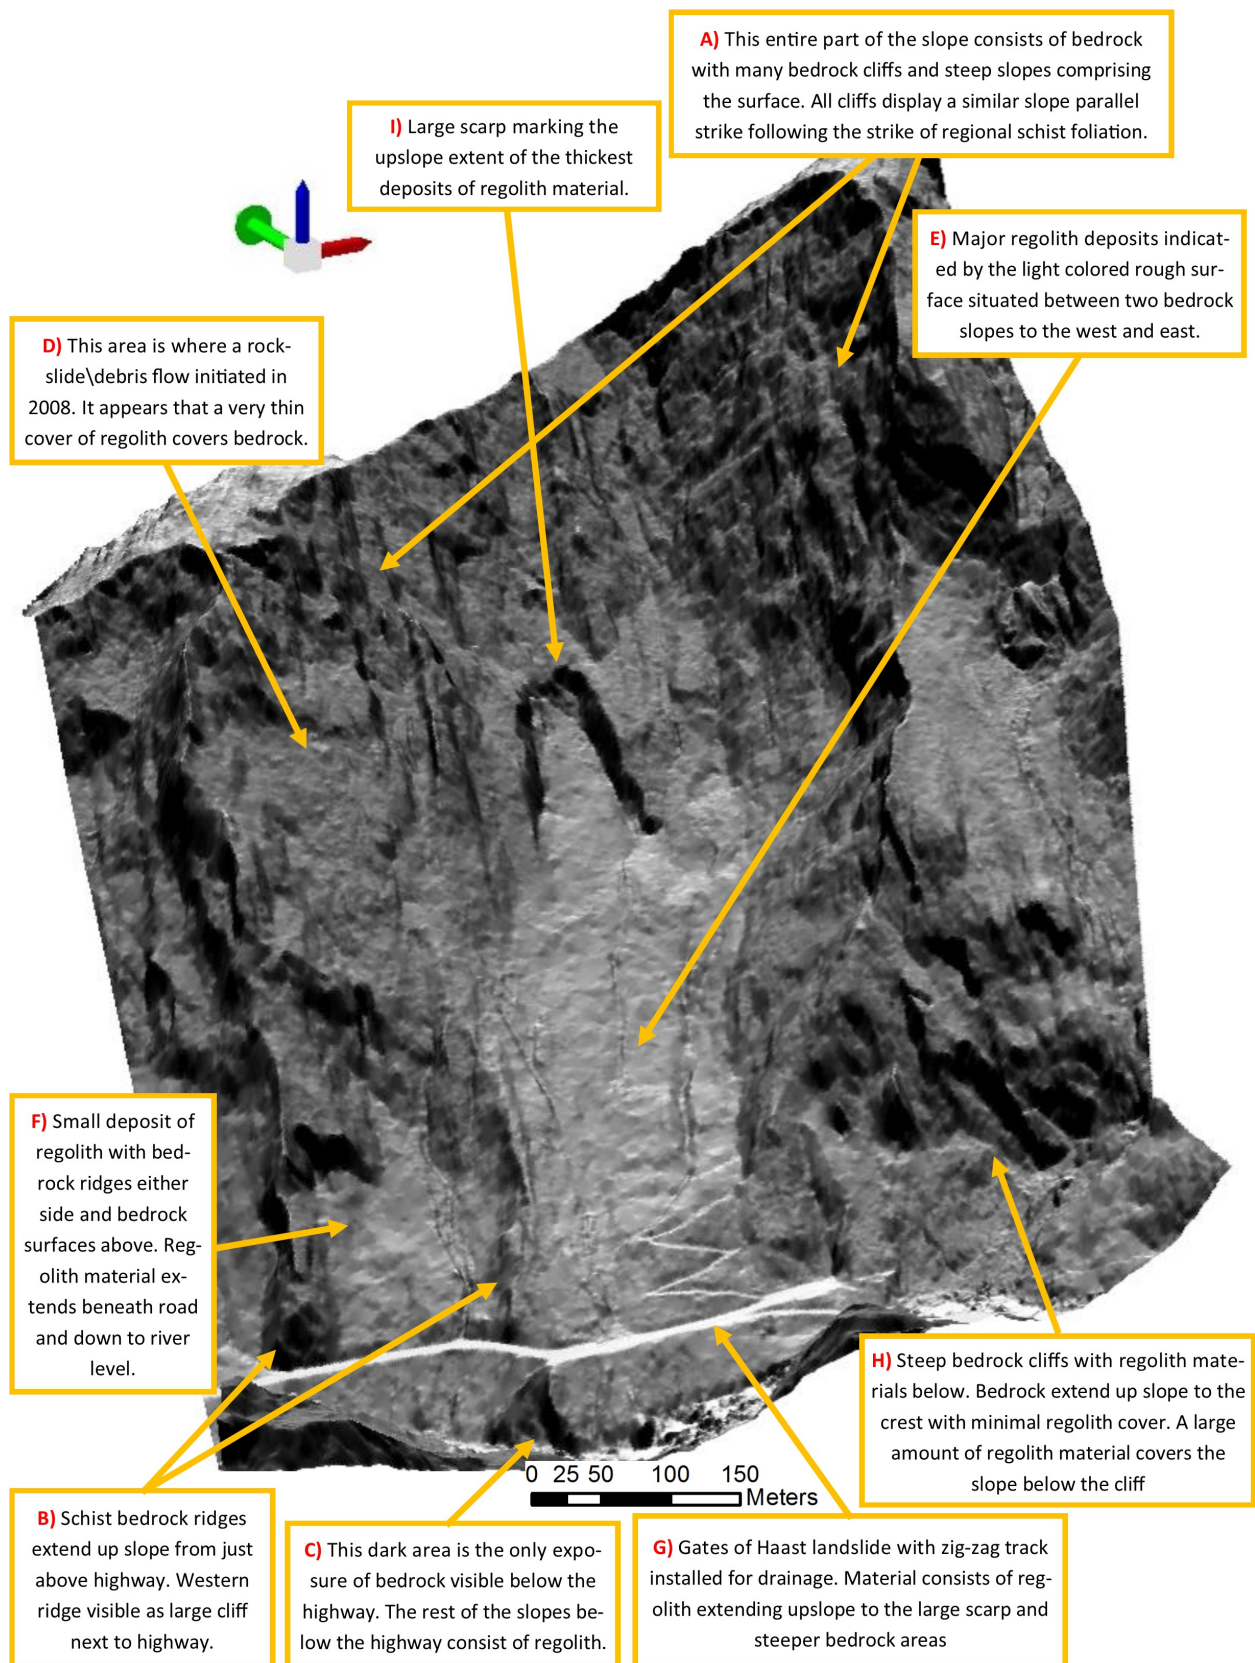
Bedrock dominates the surface of the upper slope as well as the eastern and western sides of the mid slope with only isolated areas of the lower slopes consisting of bedrock. The upper parts of the slope are almost entirely composed of schist bedrock surface with very small deposits of regolith material in isolated gullies. The upper slope bedrock surfaces are predominantly made up of cliffs that strike slope parallel aligned with regional schist foliation and steep slopes with some covered by small regolith deposits (Figure 5.14 A). On the mid slope large bedrock areas are located to the east and west of a large regolith deposit occupying the middle of the investigation area. The bedrock areas on the mid slope mostly consist of steep bedrock slopes with cliffs that are less numerous than on upper slopes. Overall slope angles are gentler as indicated by the lighter shading visible in Figure 5.14. The lower portion of the slope both above below the highway is dominated by regolith deposits. Isolated ridges of bedrock extend down from the mid slope extending down to the highway but do not appear to be visible below the highway (Figure 5.14 B). An isolated area of what appears to be bedrock is located below the highway just offset from the eastern most ridge but it is not clear if it connects with the ridge (Figure 5.14 C). The map in Figure 5.15 shows to full extent of bedrock within the investigation area.

cutting across the approximately 200 metre wide deposit (Figure 5.14 G). The eastern most deposit of regolith material on the lower slope is situated just upstream of the highway bridge and consists of regolith sourced from the steep bedrock cliffs above (figure 5.14 H). From the LiDAR surface it is clear that the highway crosses mostly regolith material sourced from landslides from the bedrock areas above. The full extent of regolith materials within the investigation is shown on the map in Figure 5.15.

Figure 5.14: LiDAR slopeshade image of The Gates of Haast investigation area.

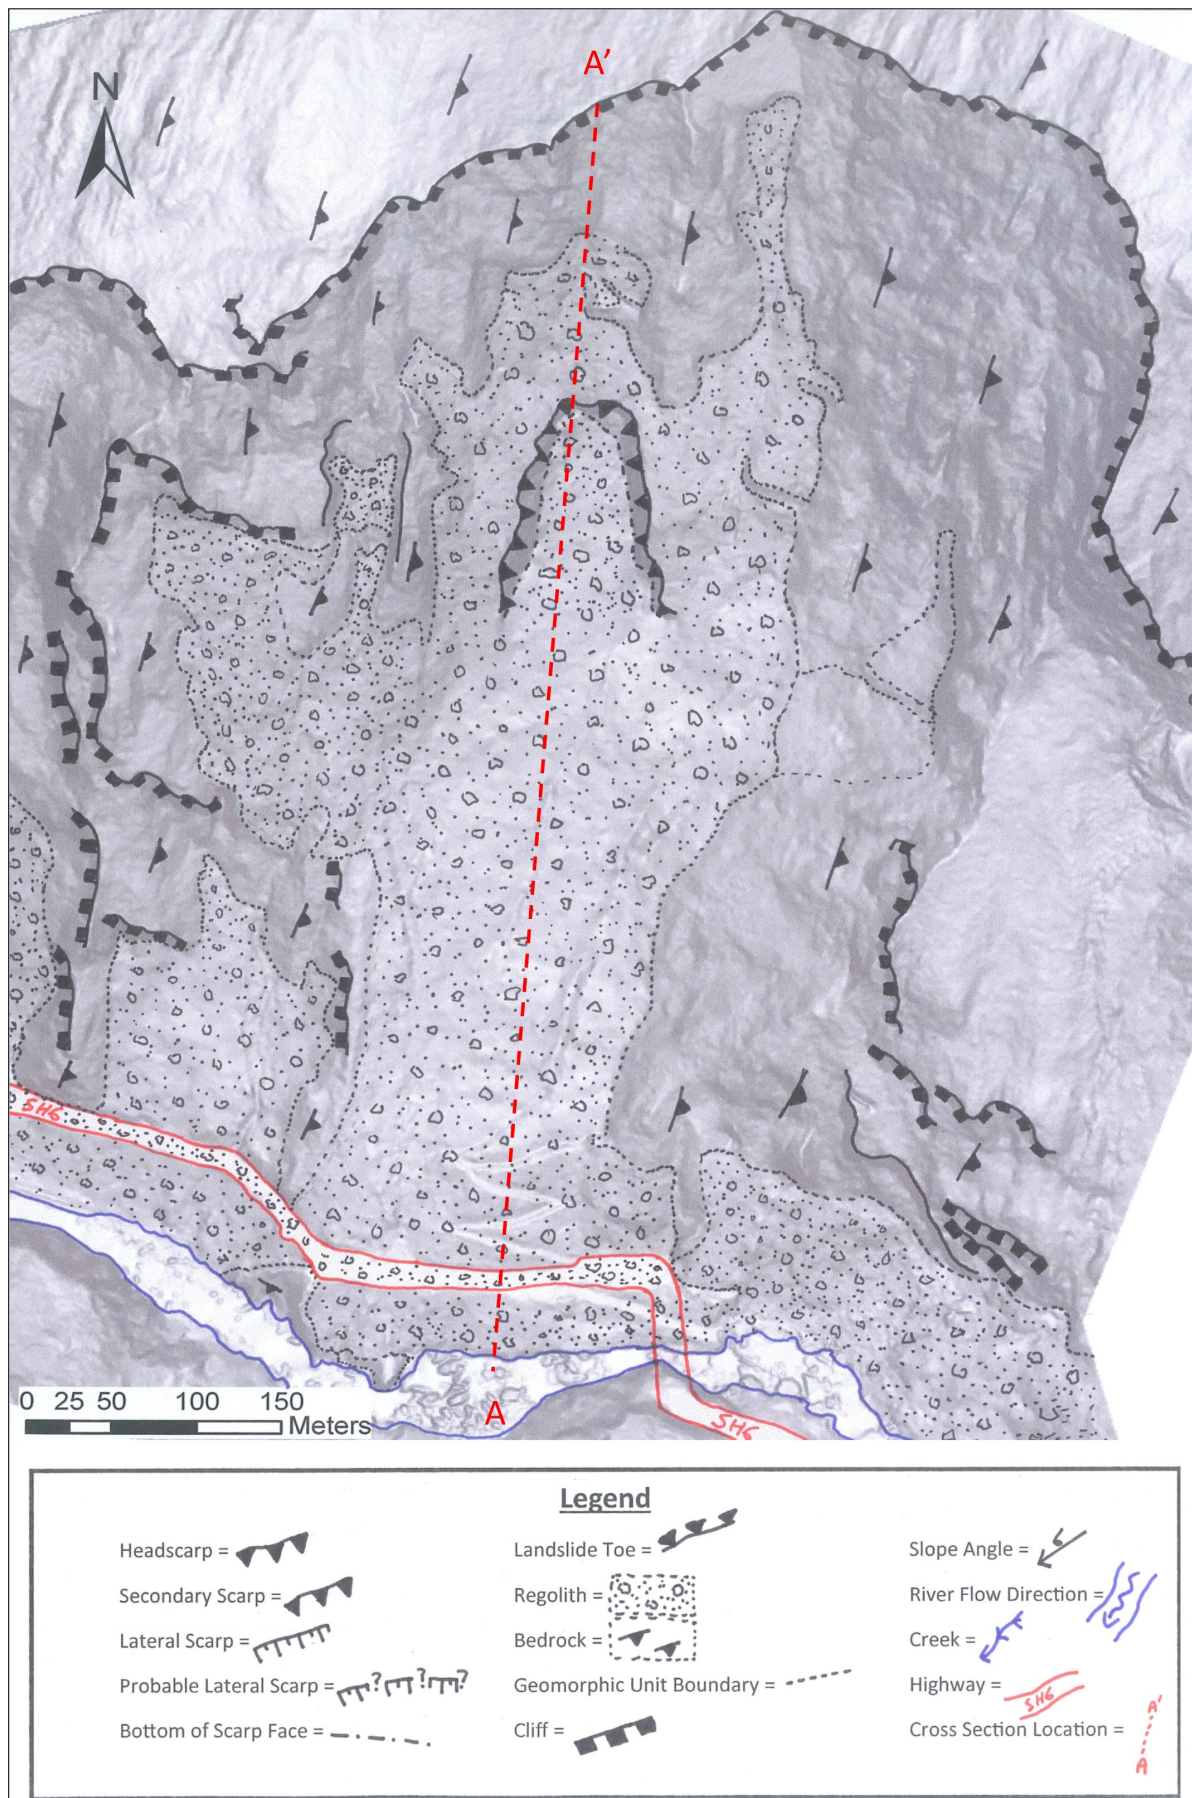
Evidence of widespread landsliding is visible in the LiDAR surface on bedrock slopes as well as within some regolith deposits. The most extensive landslide features are the numerous cliffs that are found in all the bedrock areas and are identified by the dark shaded regions of the slope shade image in Figure 5.14. The presence of so many cliffs on the slopes, particularly on the eastern upper slope, indicates that large areas of slope composed of bedrock are susceptible to landslide activity. Evidence of large scale landslide activity is the presence of a large scarp on the upper slope, visible in the LiDAR surface as the very dark area in the middle of the upper slope (Figure 5.14 I). The scarp face stands almost 40 metres tall with regolith material filling the area inside the scarp. The scarp is located at the head ward extent of the thickest deposit of regolith material and has contributed a significant quantity of material to the deposit, either suddenly during one large event or gradually through rockfall/slides and debris flows. Identification of landslide features within the regolith materials is difficult as extremely dense vegetation dramatically reduces the resolution of the LiDAR surface. Any landslide features that area present are likely to be too small in size to be detected given the nature of the surface expression as a result of slow creeping debris slides.

Figure 5.15: Engineering geomorphology map of the Gates of Haast investigation area showing the distribution of bedrock, regolith materials and landslide features.

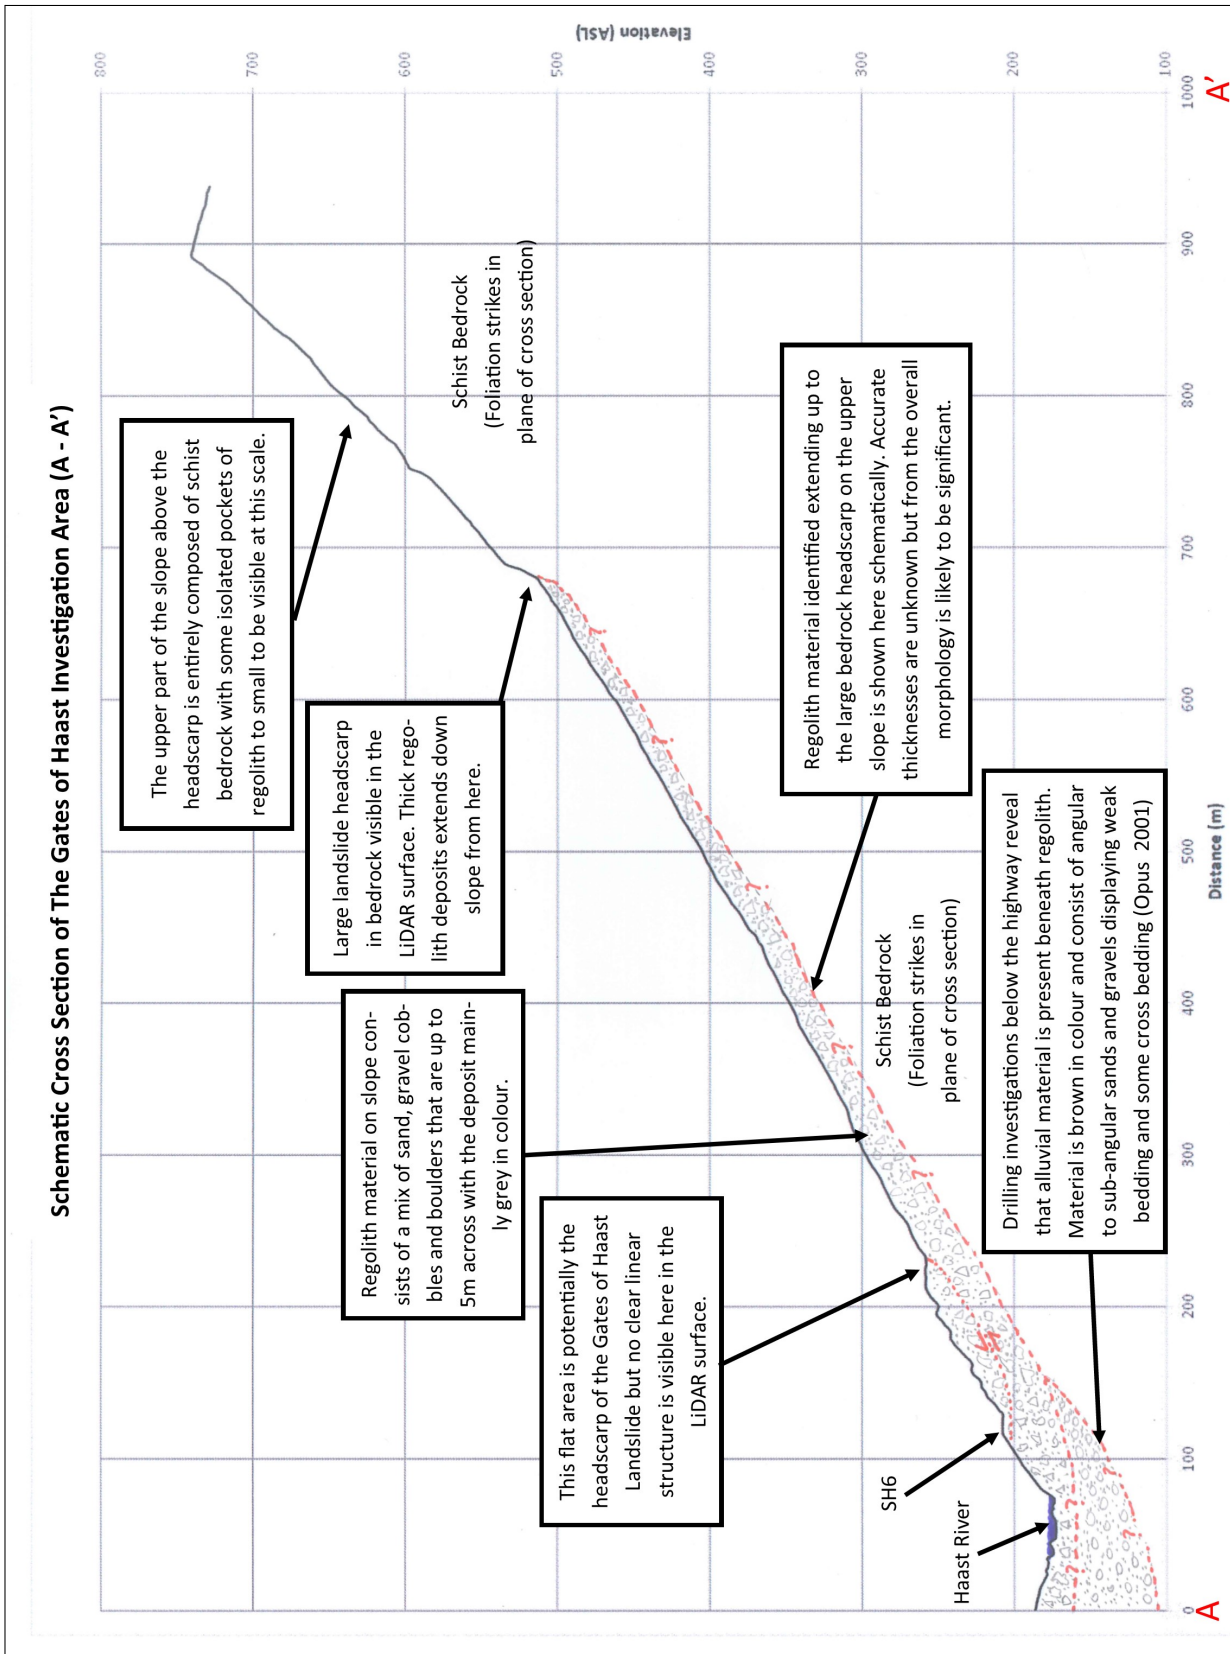
The slope subsurface of the Gates of Haast investigation area is made up of a mix of schist bedrock as well as landslide and fluvial derived regolith deposits. The cross section through the slope, in Figure 5.16, shows the interpretation of the thickness and location of these materials. Above the large bedrock scarp identified in the LiDAR surface the slopes consists entirely of schist bedrock with very minor deposits of regolith materials. Below the large bedrock scarp the slope surface is covered by landslide derived regolith materials sourced from the bedrock slopes above. The thickness of the regolith material on mid to upper slope, indicated on the cross section, is inferred from the LiDAR surface morphology rather than any subsurface data. The actual thickness may vary but based on the LiDAR surface morphology a significantly thick deposit is present. On the lower portion of the slope, in the area between the top of the zig-zag track and river level, previous engineering investigations provide more accurate information on the composition and thicknesses of the various subsurface units. Two distinct units are identified within the borehole logs from the 2002 investigation of the Gates of Haast Landslide (Opus 2001). They reveal that the upper unit consists of landslide derived regolith materials with grey colour angular sands, gravels and boulders while the lower unit consists of alluvium containing brown sub-angular to sub-rounded silts, sands and gravels some of which display weak bedding (Opus 2001). The 2002 investigation of a creeping debris slide above the highway mapped the headscarp of the failure and a flat area that corresponds

with the approximate location of the headscarp is visible in the cross section in Figure 5.16. While landslide derived regolith material was expected to cover the lower slope, the presence of alluvial material is surprising.

Figure 5.16: The Gates of Haast Investigation area cross section

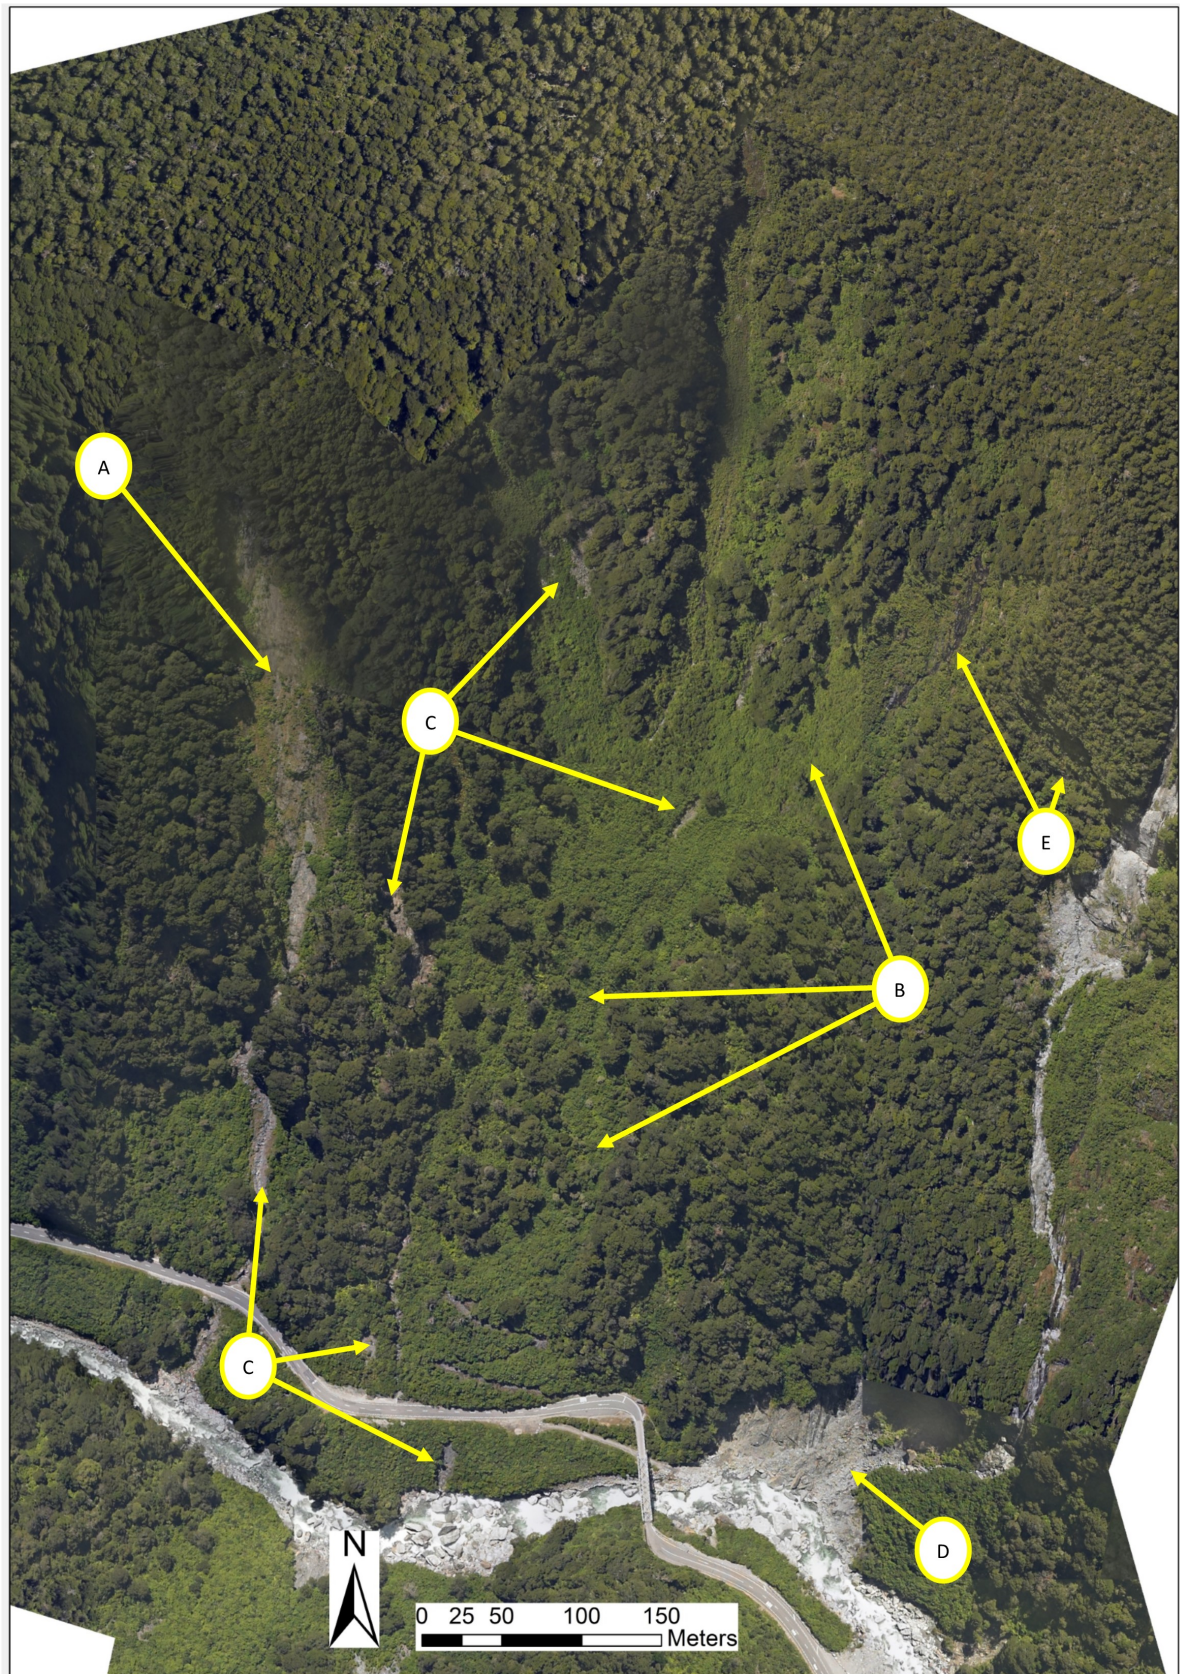
deposit on the western side appears to be a rocksliding event based on observations of the failure surface visible in the aerial photo in Figure 5.17 A.

- Older aerial photos and engineering reports from the 70's and 80's mention that debris flow activity within the large regolith deposit was common. The large regolith deposit in the centre of the investigation is completely covered by thick vegetation in the most recent aerial photo in Figure 5.17 B, but the aerial photo in Appendix E shows large areas of the slope subjected to debris flow activity with little vegetation cover. While a debris flow was recorded at the regolith deposit to the west this appears to have resulted from rocksliding/debris sliding on the upper slope that developed into a debris flow.

The evidence of continued instability on the slopes within the investigation area is clearly visible in the 2014 air photo of the area and in the 1992 historic air photo in Appendix E. Landslides from the upper areas of the slope continue to occur with the most recent failure in 2008 (Opus Report Reference) visible as the large landslide scar in the western side of the slope in Figure 5.17 A. This large landslide appears to have failed along a planar bedrock surface developed into a debris slide/debris flow towards the bottom of the slope where most of the material crossed the road and entered the river. Due to the distortion of the air photo on the eastern steep bedrock slope it is not possible to view recent rockfall events in the air photo, however, the regrowth of vegetation on the upper slopes suggests it may be in a more stable state than it was when the air photo in 1992 was taken (Appendix E). Generally failure of the regolith materials is not as extensive as it was in 1992. The entire regolith deposit in the centre of the investigation area has been re vegetated with visible debris slides consisting of small displacements of small areas of the slope (Figure 5.17 C), while small displacements of the regolith material high above the highway are unlikely to have a direct impact the presence of one small debris slide on the western side of the large regolith deposit as well as a debris slide below the highway could have a direct impact on highway operation. The largest visible regolith failure is the area east of the highway bridge on the true right bank of the river where a large area of the slope is suffering from debris sliding as a result of river incision an erosion at the toe of the deposit (Figure 5.17 D).

Figure 5.17: Aerial photo of the Gates of Haast investigation area taken in 2014.
